IN RE: ETHICON, INC., PELVIC REPAIR SYSTEM PRODUCTS LIABILITY LITIGATION THIS DOCUMENT RELATES TO WAVE 1	Master File No. 2:12-MD-02327 JOSEPH R. GOODWIN U.S. DISTRICT JUDGE
---	--

RULE 26 EXPERT REPORT OF HOWARD JORDI, PhD

III. The Scientific Literature Demonstrates That Polypropylene Mesh Devices, Including Ethicon’s Prolene TVT Device Will Undergo *In Vivo* Degradation

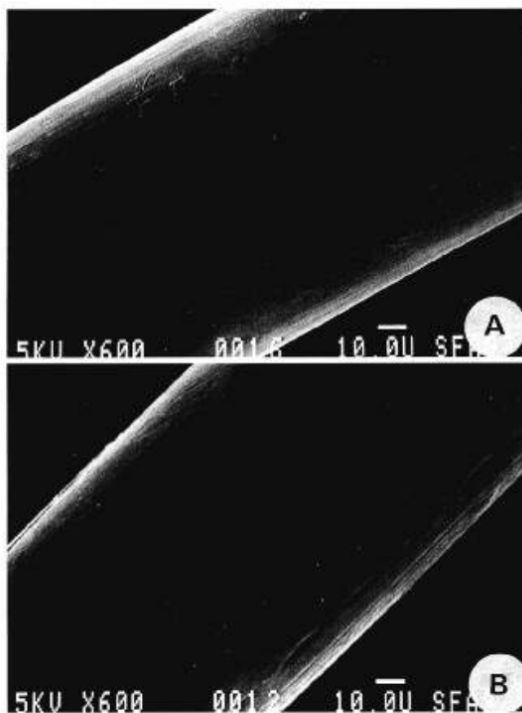
Figure 6. Scanning electron photomicrographs of retrieved and cleaned 6-0 polyvinylidene fluoride sutures showing the surface morphology after implantation for 1 (A, $\times 600$) and 2 (B, $\times 600$) years *in vivo*.

After 1 and 2 years of implantation the surface of the retrieved and cleaned PVDF sutures did not appear to be substantially modified (fig 6). In contrast, the **polypropylene sutures explanted 1 and 2 years postoperatively showed evidence of surface deterioration, characterized by uniformly spaced circumferential cracking and peeling and flaking of the polymer material in the outermost surface layer** (fig. 7) (emphasis added)

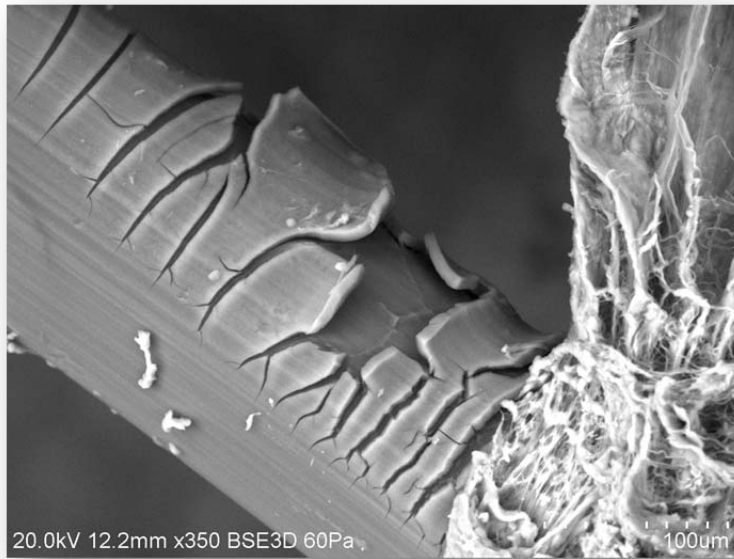
Figure 14- SEM image of explanted TVT device (Sample J7959 13409)
